**3M** ESPE

Making Better Impressions

*Trouble*

*Shooting*

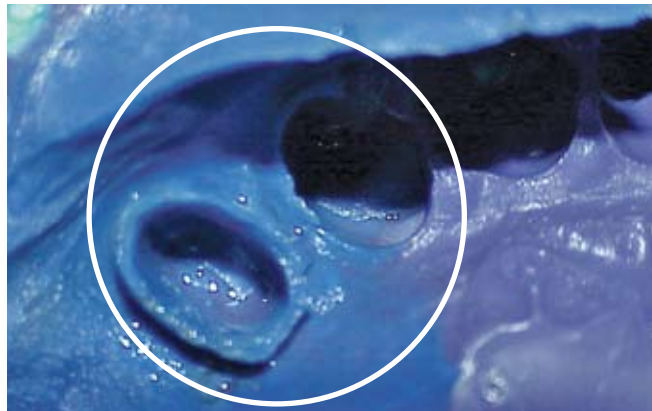
**Visual Appearance:** Impression not completely set. Shiny, no detail of site.

**Result:** Inadequate surface detail on stone cast, poor fitting restorations.

Sulfur inhibition due to contact of latex gloves with tissue/tooth/retraction material or impression material.

Residues from custom temporary or provisional cements (acrylics) present.

**Inhibited Setting**

Wear gloves proven not to contain traces of sulfur.

If contamination is suspected, scrub affected area with diluted hydrogen peroxide.

Do not use impressions already used to fabricate the temporary restoration.

Fabricate the temporary crown or bridge after final impression has been made.

Remove air-inhibited layer on the exposed surface with an alcohol wipe before making final impression.

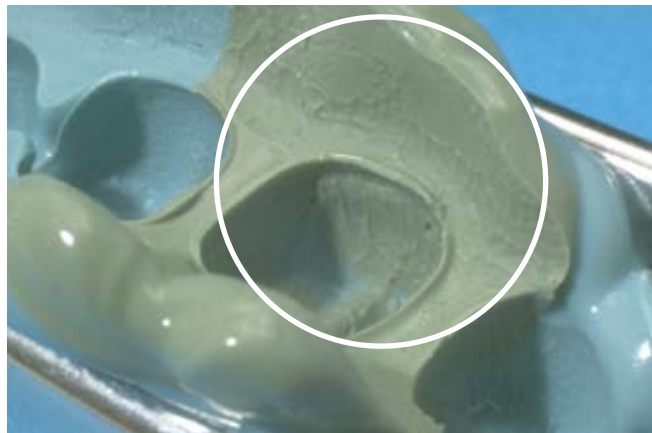
**Surface Inhibition**

Substances with pH < 4 inhibit setting reaction, most commonly by the contact with acidic retraction materials and hemostatic agents containing epinephrine or ferric sulfates.

Use retraction materials having pH  $\geq 4$ .

Select retraction materials and hemostatic agents not containing these chemicals.

Rinse, remove, dilute hemostatic solution with water spray and suction. Dry before taking the impression.

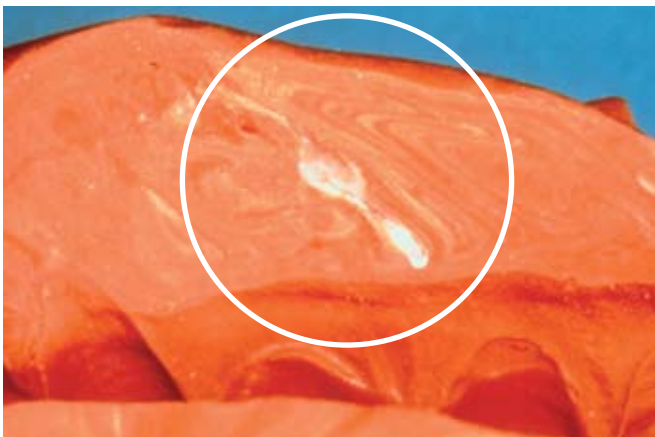
Inadequate mix.

**Inadequate Mix**

Bleed before applying mix tip to ensure even dispensing.

Use mix tip according to manufacturer's instruction for use.

Ensure mix tip is correctly attached.

When using hand-mix materials ensure correct mixing ratio and thorough mix of catalyst and base paste.

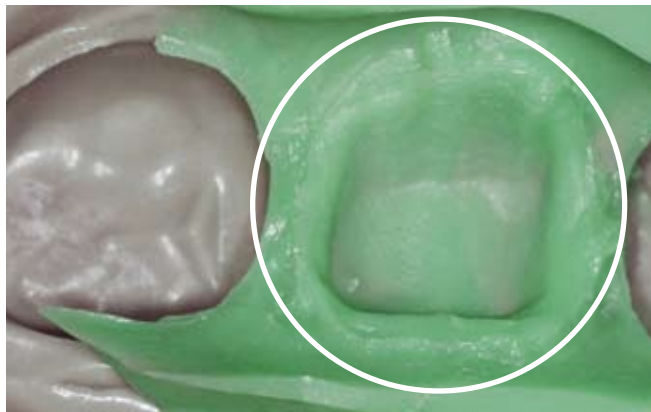
**Visual Appearance:** Muted detail reproduction.

**Result:** Crowns may be too tight, or loose, and not fit correctly.

**Lack of Impression Detail**

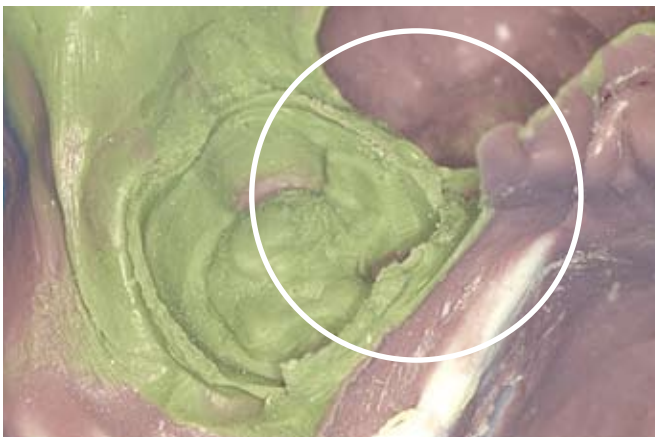
Poor Retraction and Syringing Technique

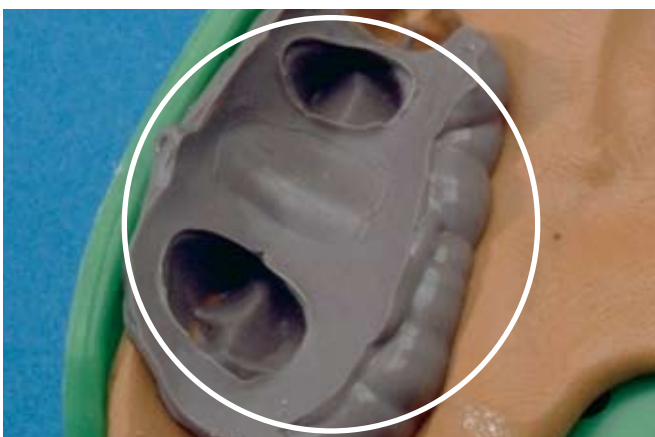
Exceeding the Working Time

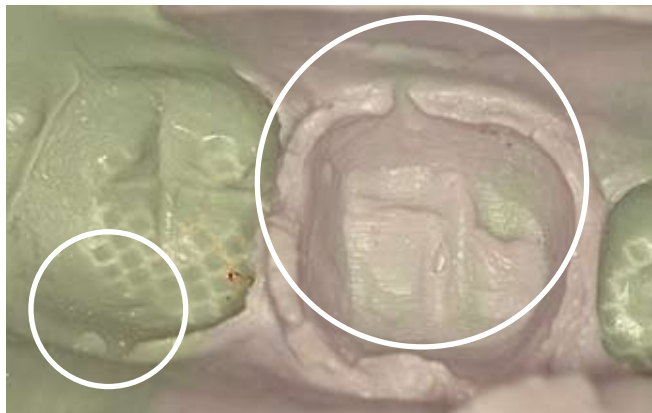
**Visual Appearance:** Voids/holes on margin of the prepared teeth. Incomplete margin.

**Result:** The fit and function of the final restoration may be compromised. Short crown margins and/or open margins.

**Void Caused by Syringe Technique**

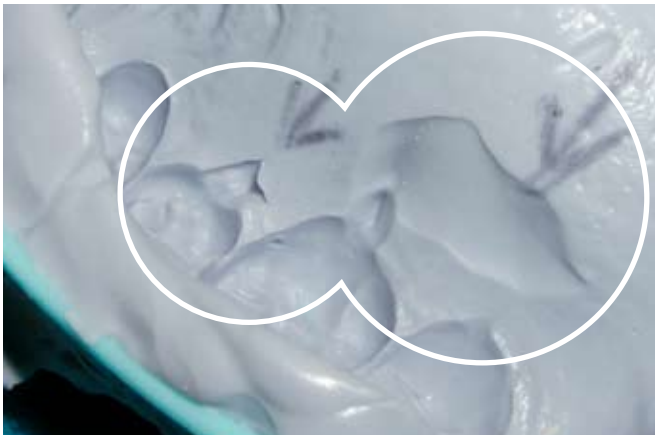
Blood and saliva contamination around prep.

Trapped Air or Moisture

Use good moisture control technique. Rinse and dry prep area before taking the impression.

Stop bleeding by using appropriate retraction technique and hemostatic agent. Leave cord in sulcus until no blood or saliva are present before syringing the light body impression material. Consider two-cord retraction to displace tissue and control fluids.

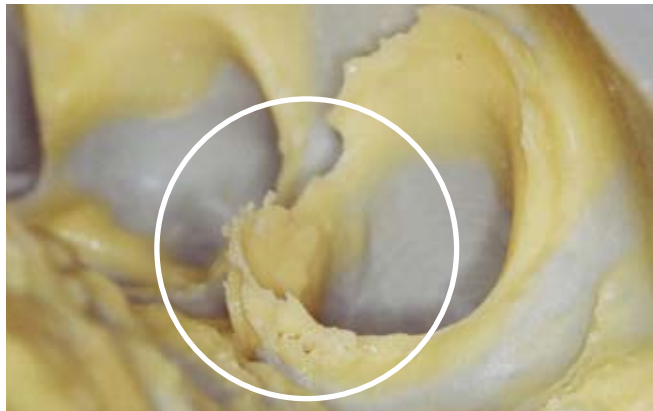
**Visual Appearance:** Rip, or visible tearing on the margin of the preparation.

**Result:** Short crown margins and/or open margins.

**Poor Retraction — Insufficient Tear Resistance**

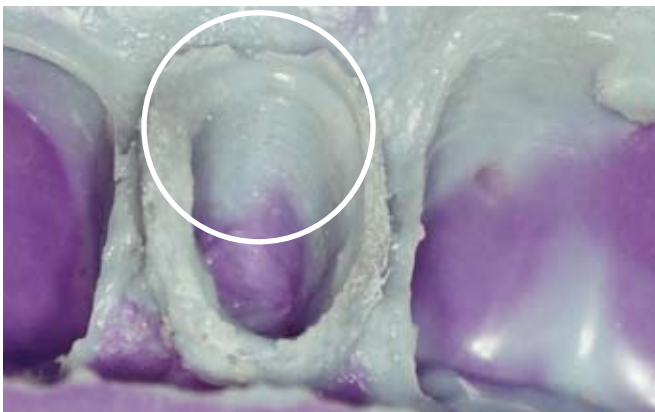
Tearing at the Margin

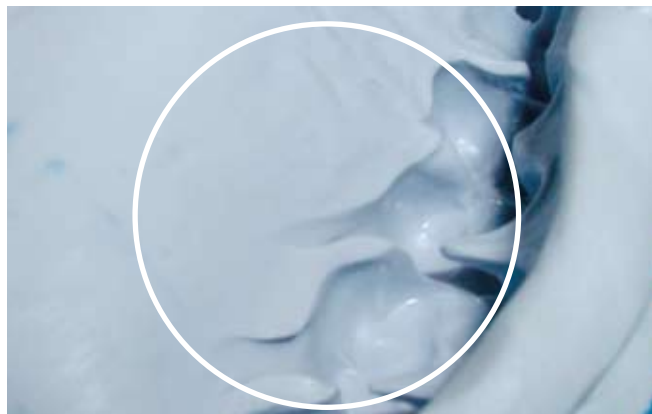
**Visual Appearance:** V-shaped void, trough-like.

**Result:** Failure to capture complete and accurate dentition.

CAUSE	SOLUTION
Exceeding the working time.	Follow manufacturer's working time specifications.  Choose material with longer working time.
Tray movement or repositioning after seating.	Do not move tray after seating.
Insufficient amount of impression material used.	Use more material to create back flow effect.
Impression tray does not support flow of impression material.	Use lingual stops.  Use an impression tray that supports the flow of the material.

**Lingual Pulls**

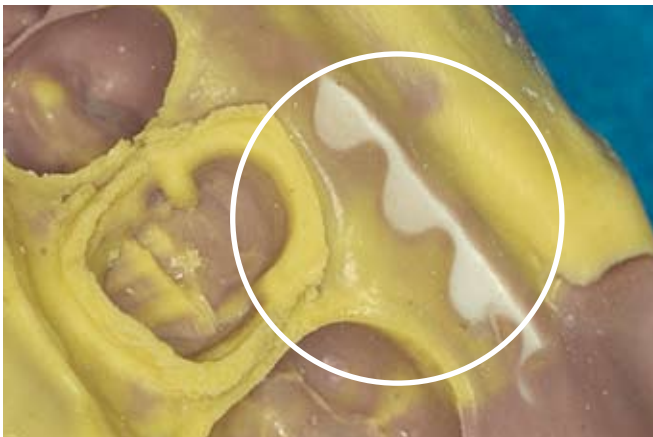
**Visual Appearance:** Show-through of tray. Impression tray exposed.

**Result:** Restoration may have slight distortion at marginal area, or rocks.

CAUSE	SOLUTION
Prepared teeth contact the sides or bottom of impression tray.	Use proper size tray. Test various tray sizes to ensure proper size.
Tooth contact with the pre-set tray material when using the two-step technique.	Carve out tray material properly before applying wash.
Insufficient impression material used.	Fill tray adequately.

**Contact with Impression Tray**

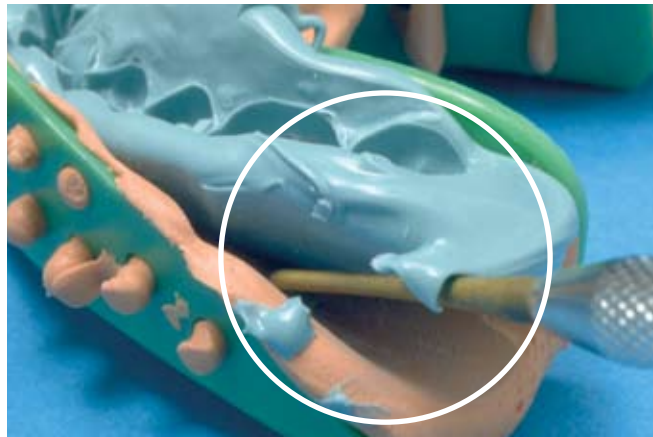
**Visual Appearance:** Heavy body and light body materials not blended, or mixed together.

**Result:** Restoration will not seat or fit properly.

Exceeding the working time.

Impression material stored at elevated temperature.

Sulfur or acrylic contamination of pre-set heavy body material in two-step technique.

**Poor Bond Between Heavy Body and Light Body Material**

Follow manufacturer's working time specifications.

Choose material with longer working time.

Store impression material at room temperature.

Avoid contact with sulfur contaminants:  
Wear gloves proven not to contain traces of sulfur.

Avoid contact with acrylic and methacrylic contaminants: Ensure impression material does not come into contact with methacrylate residue from acrylate temporary materials.

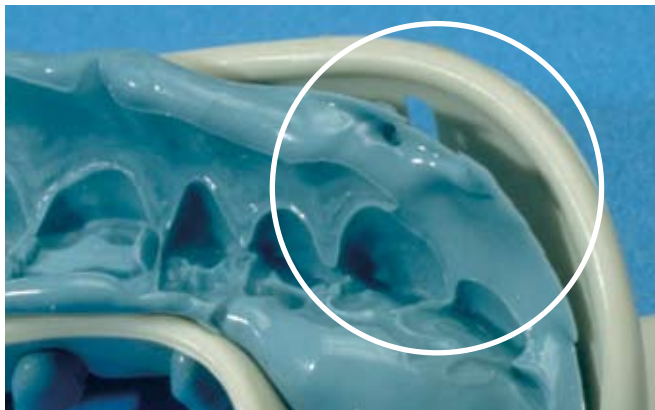
**Visual Appearance:** Impression pulling away from the sides/bottom of tray.

**Result:** Crown(s) may be tight and not seat fully, or require excessive internal adjustment.

CAUSE	SOLUTION
No tray adhesive used.	Use tray adhesive.
Incompatible tray adhesive used.	Use appropriate tray adhesive. VPS adhesive for VPS. Polyether adhesive for polyether materials.
Inadequate drying time for tray adhesive.	Follow manufacturer's instructions for application, and drying time.
Thin plastic trays allow deflection, which can cause rebound upon removal.	Use a tray that fits better, and is stiffer and more rigid.

**Separation of Material from Tray**

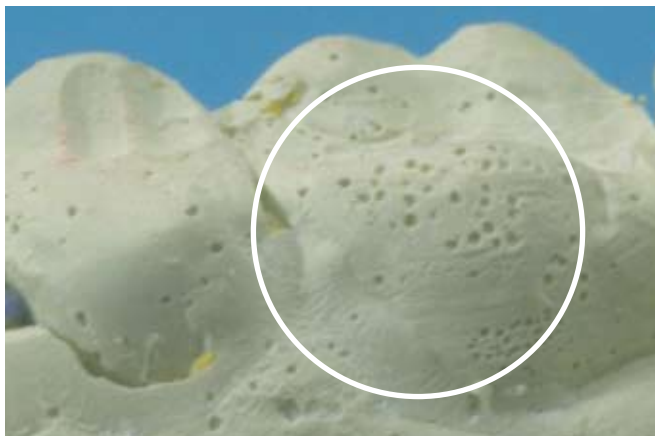
Hydrogen gas emission.

Stone Model with Hydrogen Evolution Voids

Follow manufacturer’s instruction for casting time.

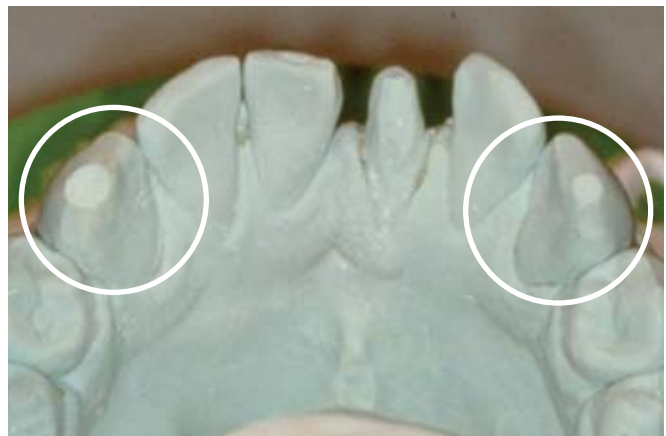
**Visual Appearance:** Voids on margin, powdery cusp tips on incisal edges on prepared tooth. “Golf-ball” appearance of stone model.

Tooth contact with impression tray, or gauze of double bite tray causes water to leach out of the tray, dehydrating the stone.

Stone Model with Powdery Cusp Tips

Instruct patient to bite passively in centric occlusion when using dual arch trays.

Fill tray with sufficient amount of material.
